REDUCED COLIFORMS & INCREASED ORP AT STORMWATER RETENTION BASIN IN CALIFORNIA

Client Case Study: Stormwater Basin

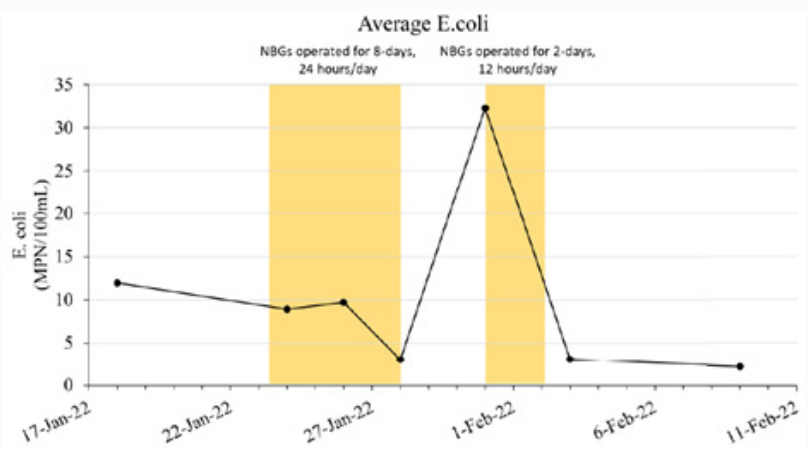
Figure 1: Average E. coli before, during and after nanobubble treatment.

To measure the conditions that cause odors, dissolved oxygen and oxidation-reduction potential (ORP) profiles were collected at four sampling locations across the basin over the course of treatment. At the benthic layer, average dissolved oxygen concentrations increased from less than 0.5 mg/L to 4.4 mg/L. Additionally, ORP levels increased from an average of -260mV to 160mV demonstrating a shift towards a more oxidative environment in which odor-causing sulfides are not produced. Microbial testing for E. coli and total coliforms was also conducted and indicated a reduction of 75% across both parameters.

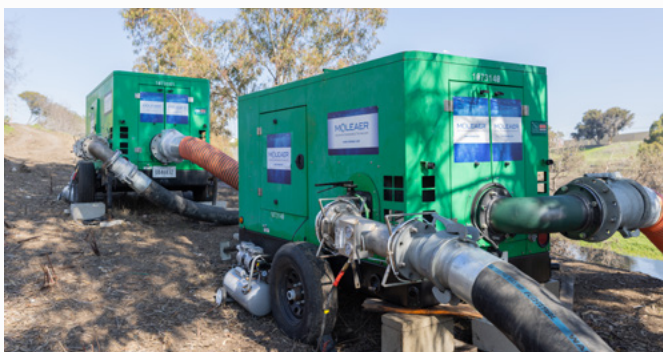
Figure 2: Flexible installation was required for this project.

To address both anoxia and microbial contamination concerns, Moleaer installed two 2,200-gallon-per-minute (GPM) trailer-mounted air nanobubble generators to recirculate on the basin. The nanobubble generators were installed after a rainfall event and operated for two weeks until the water level had decreased below the suction lift capacity of the nanobubble generator pumps.

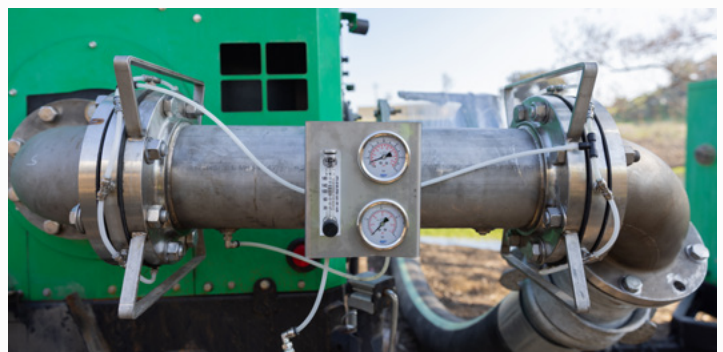
Figure 3: Moleaer's nanobubble generators are modular and scalable to fit any installation.
